0. AN ACCIDENT ROOTED IN HISTORY - Story Preface

**2. AN ACCIDENT ROOTED IN HISTORY**

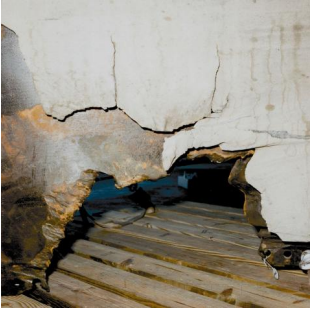
### Challenger - Area Depicting Burn-Through in the Right SRM

This public-domain NASA image pinpoints the place where the accident causing the loss of *Challenger* began. NASA describes the image with these words: "Shown here is an interior view of the scorched hole in Space Shuttle *Challenger's* right Solid Rocket Motor. The tapered edges along the hole indicate the inside to outside path of the fire that led to the accident." Click on the image for a full-page view.

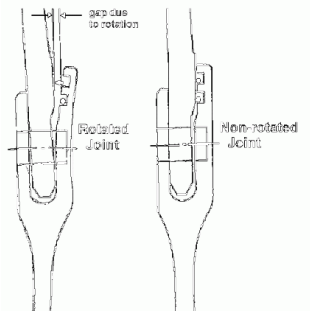
### Illustration of Rotated Joint on Solid Rocket Motor: Space Shuttle

Eroded O-rings led to misaligned ("rotated") joints. Misaligned joints led to undesirable things like exhaust gas blowing through, and out of, the solid rocket booster. Exhaust gases must be kept away from the shuttle's external tank (which contains liquid hydrogen and liquid oxygen).

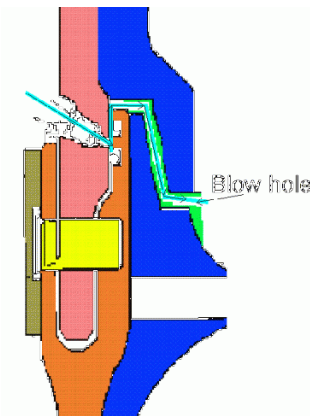
## Space Shuttle: Failed O-Ring Causes Blow Hole

The primary culprits were the rubber "O-rings" used to seal joints. Especially in cold weather, the O-rings had a tendency to erode. When they eroded, they could no longer completely seal joints.

If the rings were not properly sealed, gases would escape. Morton Thiokol and NASA knew that before the *Challenger* disaster.
