U.S. Fire Administration/Technical Report Series

# The World Trade Center Bombing: Report and Analysis

New York City, New York

USFA-TR-076/February 1993

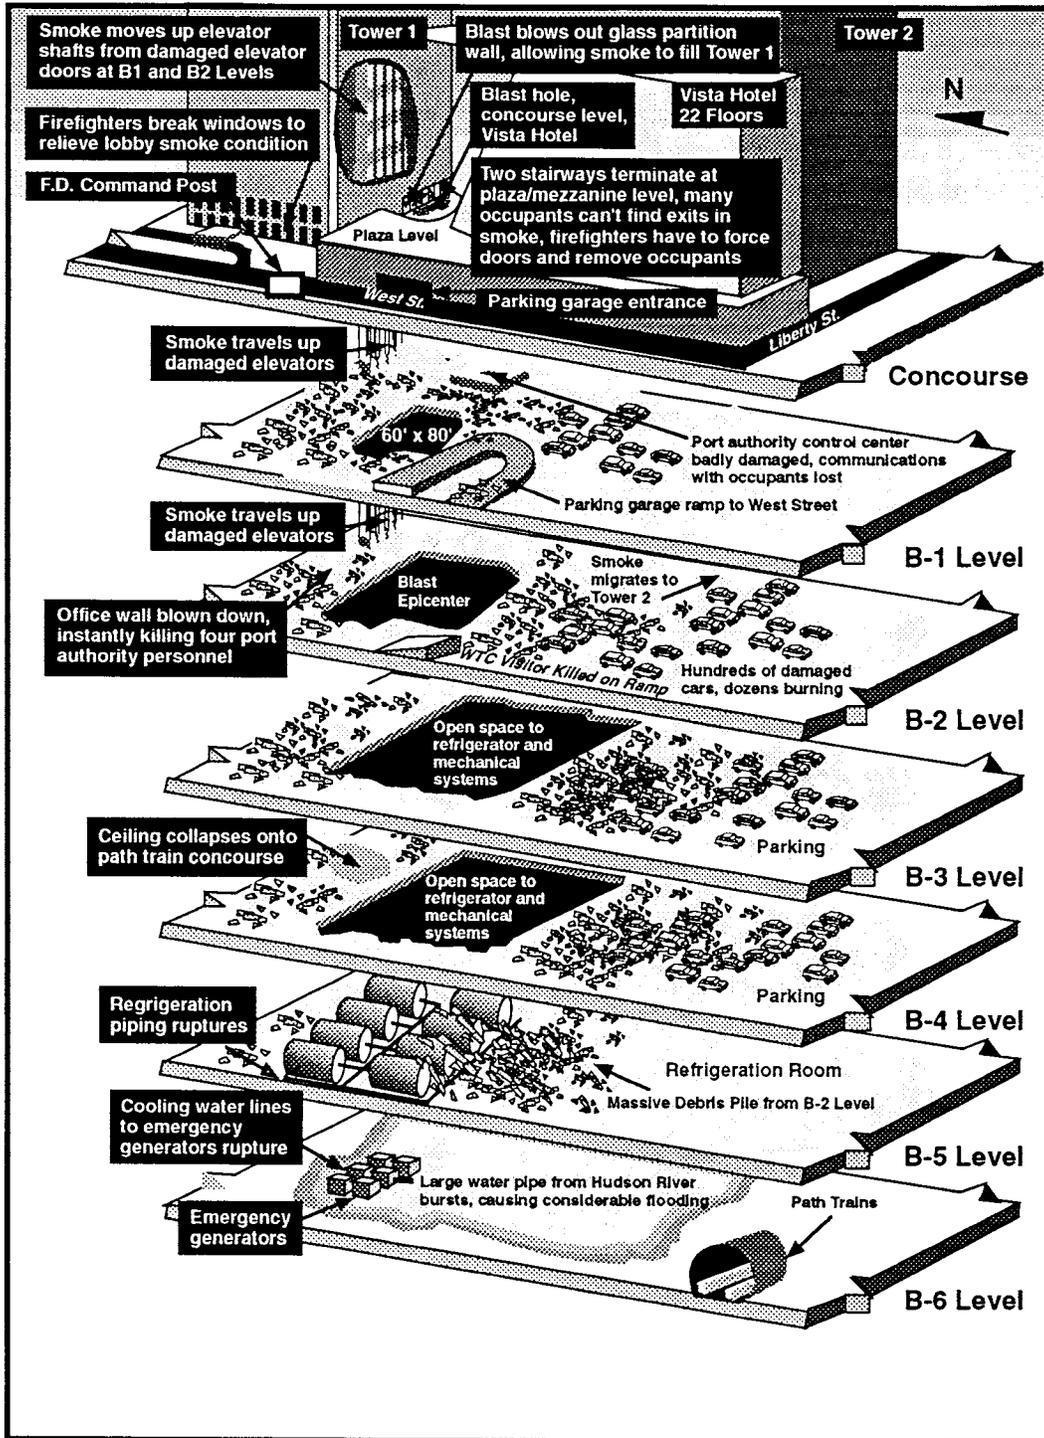
# Blast Damage

**Damage/hazard assessment.** Lights were brought into the below-grade areas. Damage from the blast was extensive. The B-2 level surrounding ground zero was completely destroyed. Piping and conduit were snapped like twigs. Masonry walls and steel-reinforced concrete flooring were blown apart. Cars were strewn about like toys. Steel columns were shocked but held.

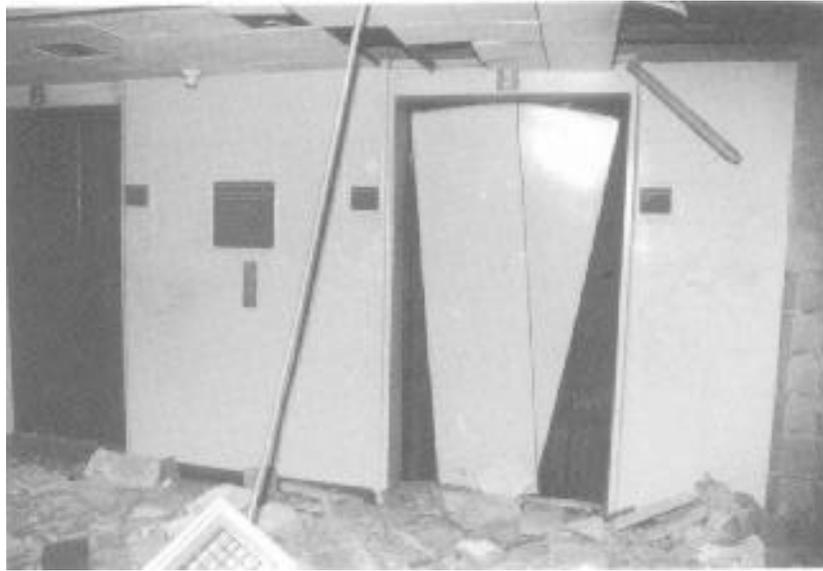
**Damaged elevator doors and enclosures on the B-2 level presented a vertical channel for smoke spread into Tower 1.**

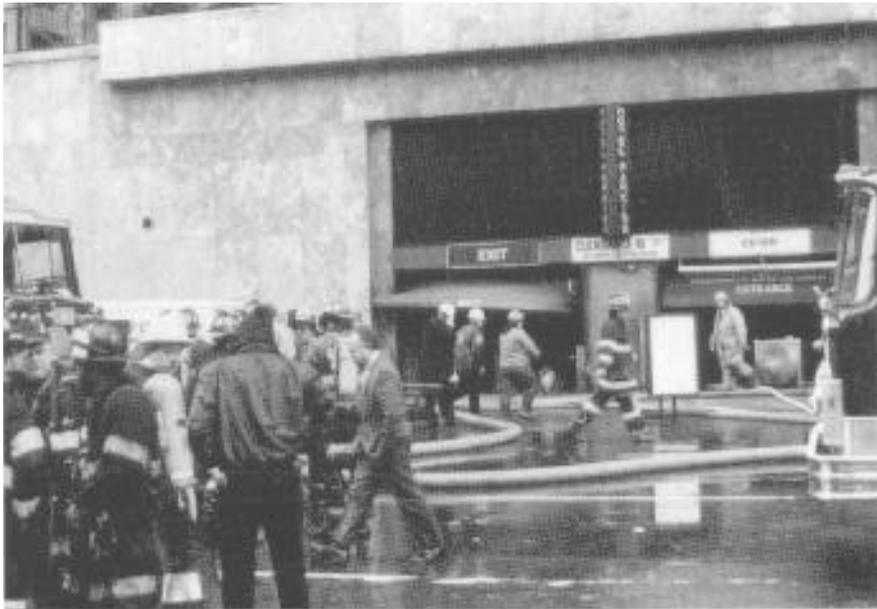
**The scene on West Street within the first hour of the incident. The Vista Hotel is to the far right, and Tower 1 is next to it. The parking garage entrance is visible. Note also the tower ladder raised to the plaza level to remove occupants trapped at that level.**

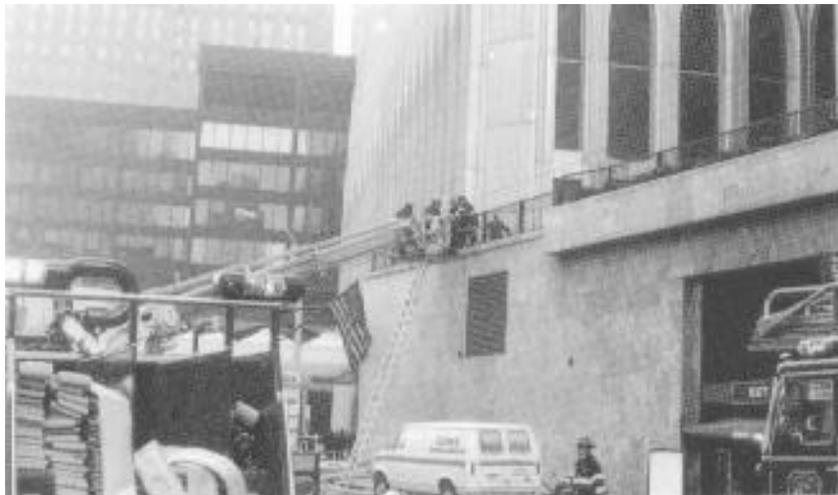
**A view of the parking garage entrance on West Street, through which first fire companies launched the initial fire attack.**

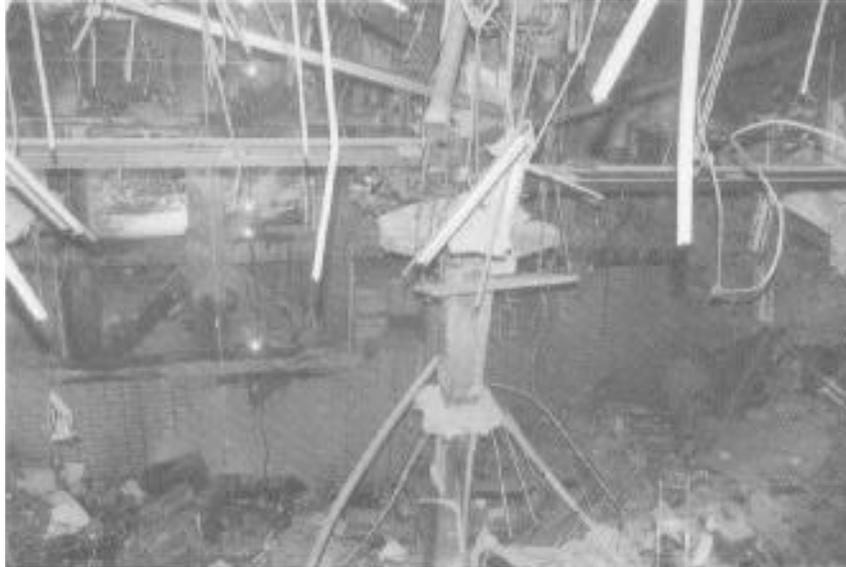
**A view of the crater from the B-1 to B-5 levels. Noe the steel column. Horizontal supports were destroyed in some cases, but the columns did not give.**

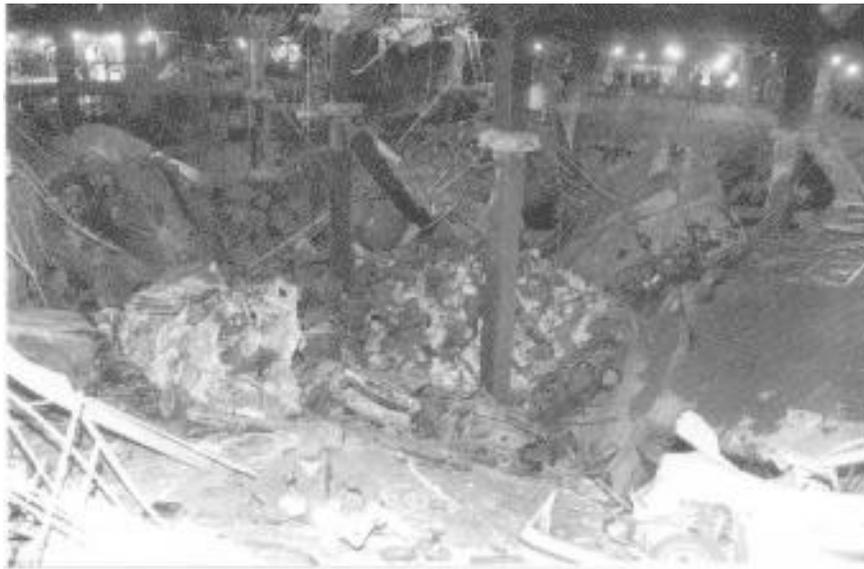
**The crater, looking from the B-2 level down to B-5, taken during the investigation/restoration phase.**

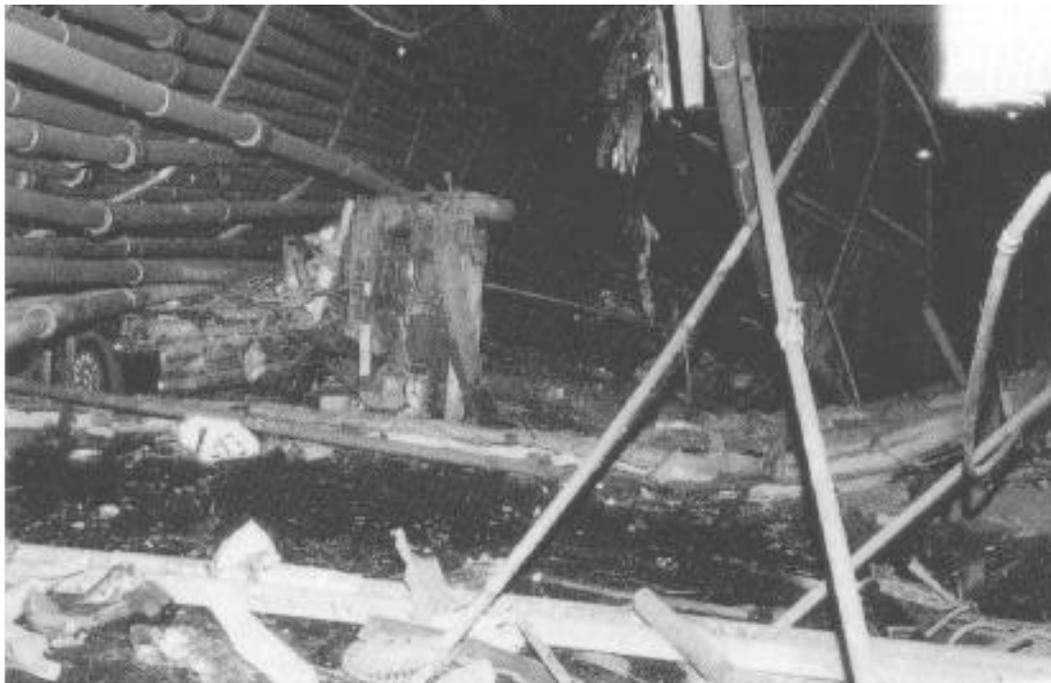
**Building systems in the vicinity of the blast were destroyed. Here, twisted electrical conduit has landed on top of what was once a car.**

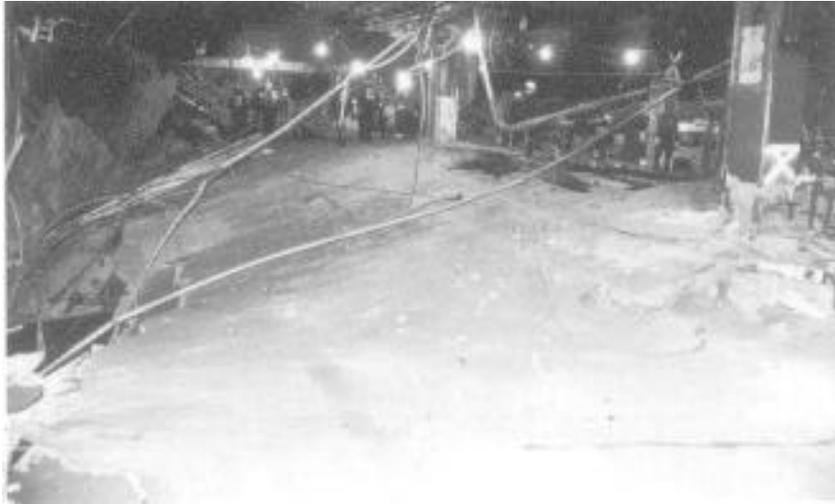
**The sloping, hanging steel-reinforced concrete floor at the perimeter of the crater was a major hazard for units operating on the crater fire, particularly in the heavy smoke condition.**

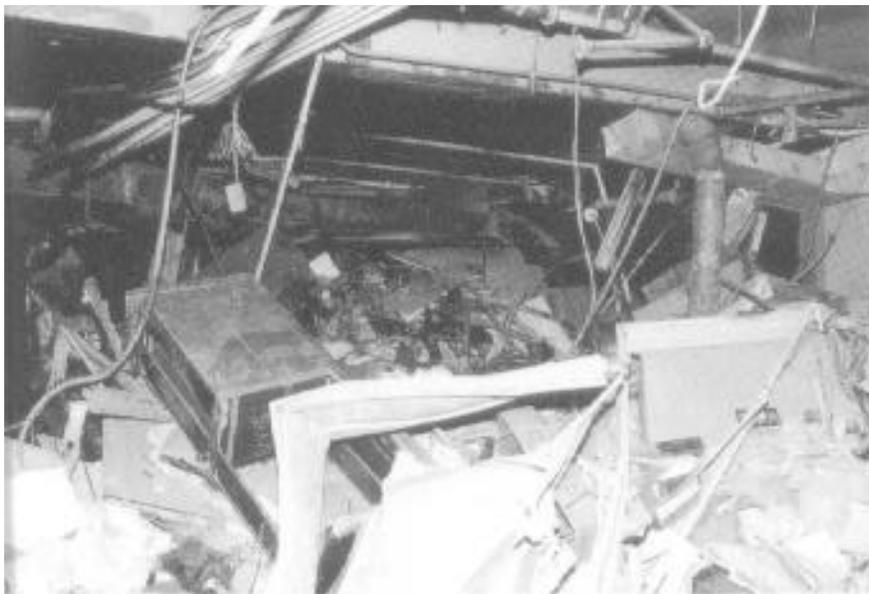
**This destroyed office area on the B-2 level is typical of the debris piles faced by searching firefighters.**

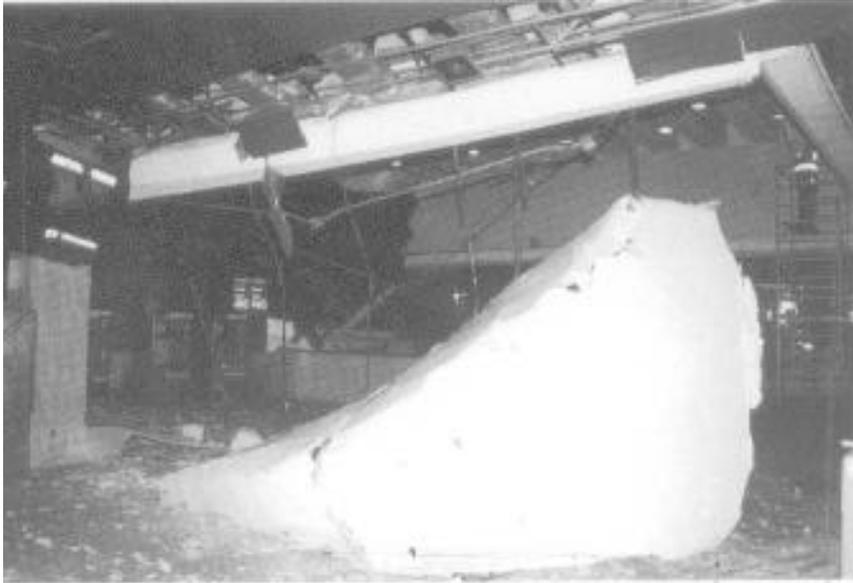
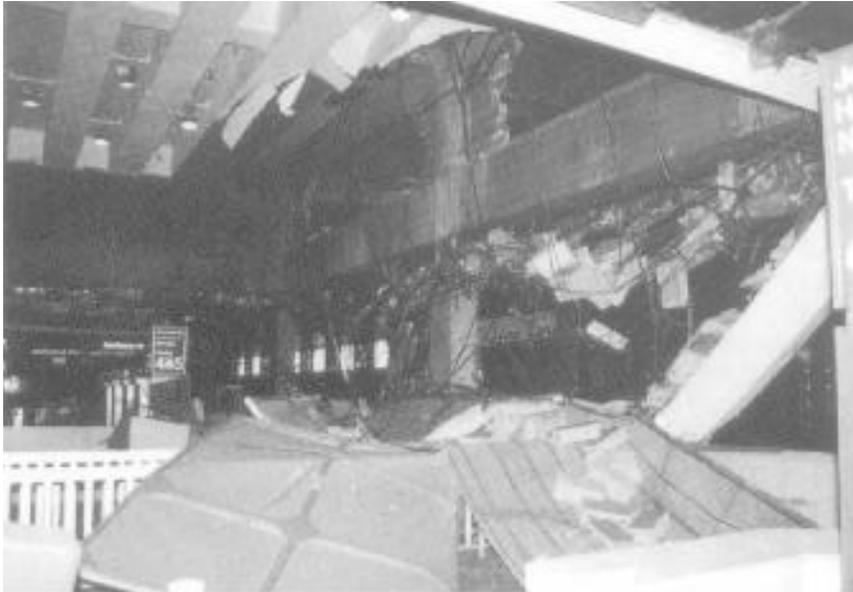
The explosion collapsed a portion of ceiling on the B-5 level onto a PATH train concourse.

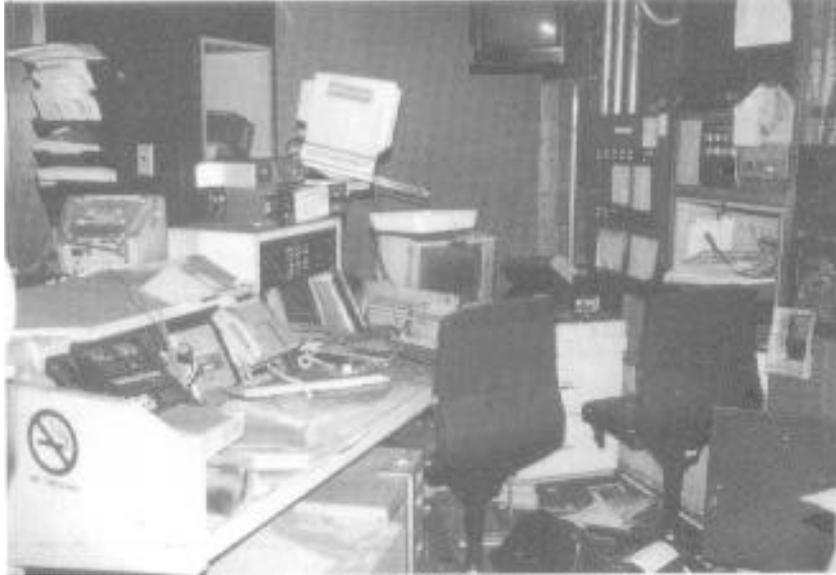
**The Port Authority Command/Communications Center on the B-1 level, approximately 50 feet from the blast hole on that level, was damaged and communication with occupants in the towers was lost.**

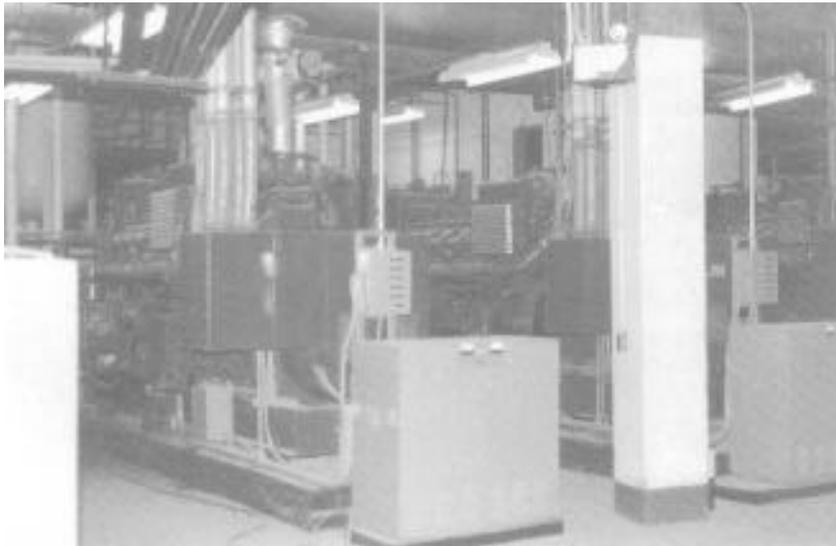
**Emergency generators on the B-6 level. Cooling water lines for these unit were ruptured by the blast, shutting down all emergency power.**

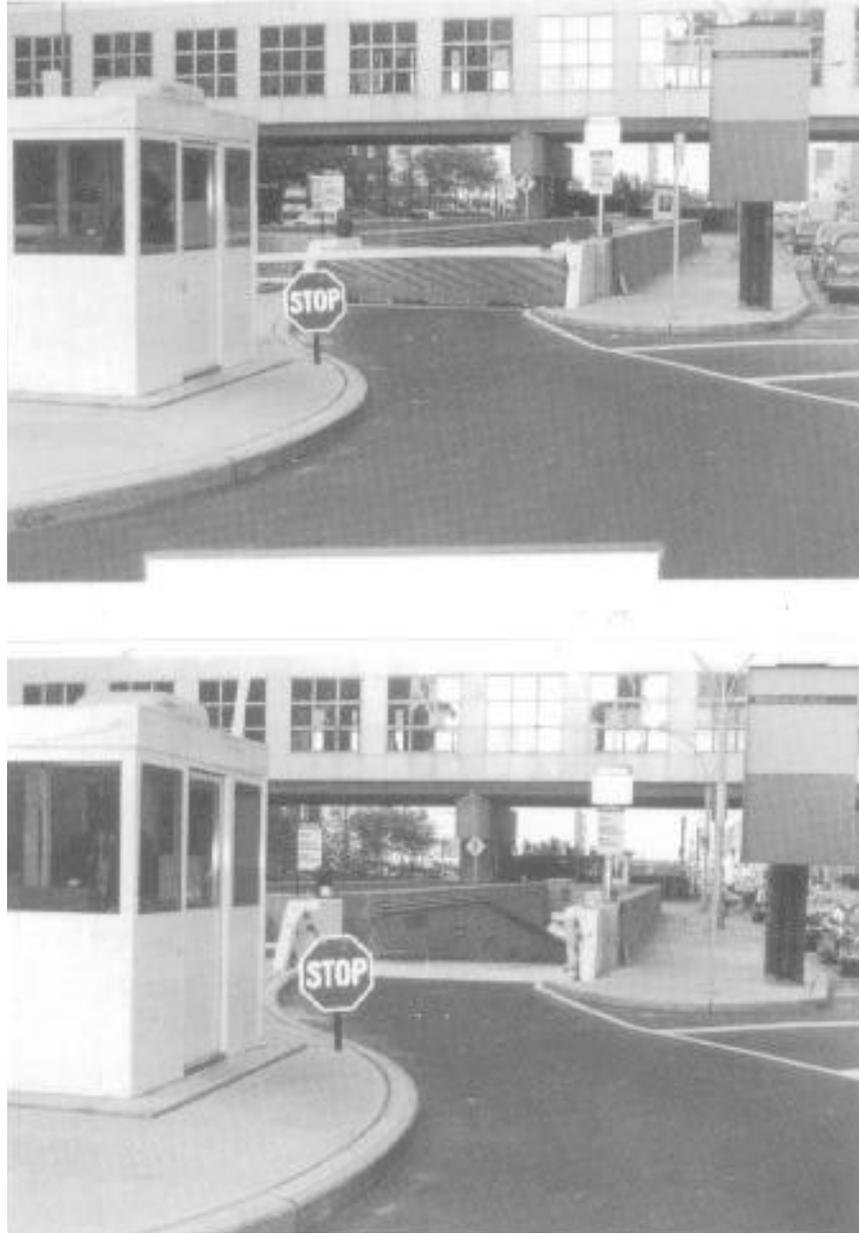
**Controlling access to public buildings is a major concern for building management. After the incident, Port Authority, in addition to many security changes, installed substantial barriers to unauthorized vehicle access. The barrier, controlled by security personnel in the booth, folds down when the driver has been cleared to enter.**
