0. ORBITER HEAT TILES - Story Preface

**4. ORBITER HEAT TILES**

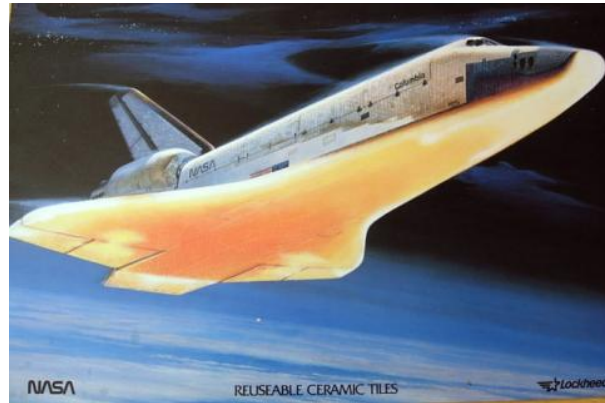
NASA's Goddard Institute for Space Studies [explains why](#) early shuttle missions "had problems with thermal insulation tiles. These tiles are important because vehicles reentering the atmosphere at high speed are heated by collisions with air molecules. Part of the energy from these collisions goes into heating the surface of the vehicle and the remainder goes into internal energy of the air molecules so that there is also a layer of very hot gas around the vehicle." The image depicts an artist's rendering of *Columbia's* heat tiles at work during reentry. Click on it for a closer view.

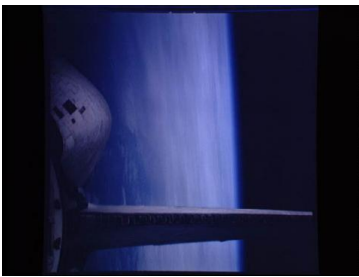
### View of Tiles

Coated black ceramic [tiles](#) (known as High-Temperature Reusable Surface Insulation) cover many areas of the shuttle. They are found on its lower surface; in areas around the forward windows; on its upper body flap; at the base heat shield; on the "eyeballs" at the front of the Orbital Maneuvering System (OMS) pods; and on the leading and trailing edges of the vertical stabilizer and the [rudder speed brake](#).

Black tiles are [located](#) where temperatures on the outside of the shuttle are extreme.

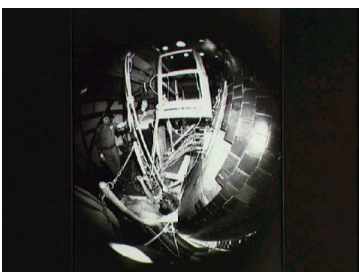
### Replacing Damaged or Missing Tiles

The small (six-by-six-inch) tiles are easily repaired or [replaced](#) while the shuttle is on the ground. A technician, for example, worked on [tiles underneath](#) *Columbia* as she was readied for her STS-28 mission. Crew members from that same mission inspected [those tiles](#) on 13 August 1989, after the mission was safely completed.
