0. AN ACCIDENT ROOTED IN HISTORY - Story Preface

**2. AN ACCIDENT ROOTED IN HISTORY**

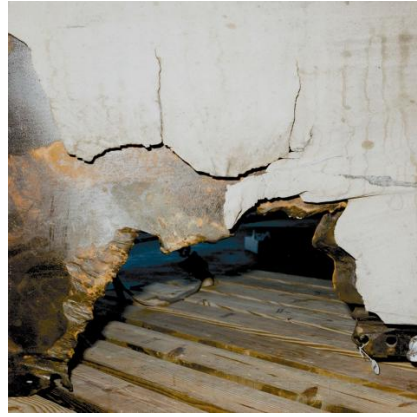
This public-domain NASA image pinpoints the place where the accident causing the loss of *Challenger* began. NASA describes the image with these words: "Shown here is an interior view of the scorched hole in Space Shuttle *Challenger's* right Solid Rocket Motor. The tapered edges along the hole indicate the inside to outside path of the fire that led to the accident." Click on the image for a full-page view.

Although they appeared to perform well (to those not on the inside track), the solid rocket boosters had a fundamental, potentially fatal design flaw.

Erosion of the O-rings had been noted by Morton Thiokol and NASA after other shuttle missions. Because the rings had not failed, however, officials decided the erosion was an "acceptable" flight risk.
