Why did the offshore drilling rig, *Deepwater Horizon*, explode on April 20, 2010? It all started when the rig was ready to move on, leaving behind the oil well which its crew had drilled.

In its report of 8 September 2010, BP identified eight main failures which caused *Deepwater Horizon’s* explosion. We can breakdown BP’s analysis of the eight main failures—identified at [pages 10-11 of its report](#)—as follows:

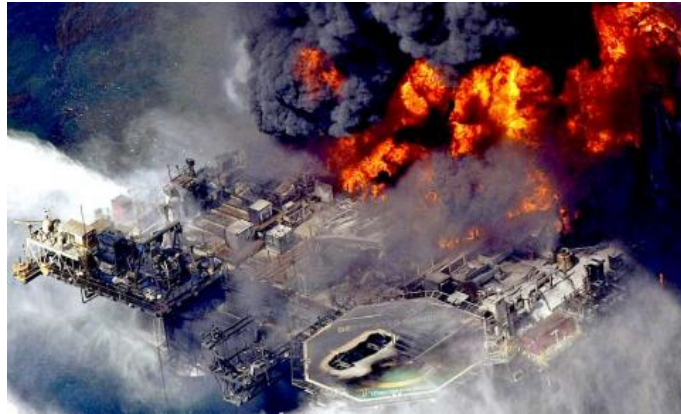
*Deepwater Horizon* burns on April 21, 2010—the day after catastrophic explosions occurred aboard the offshore oil platform. The next day, the rig would sustain another explosion, causing it to sink in the Gulf of Mexico. AP Photo used here as fair use for educational purposes. Click on the image for a better view.

Image of *Deepwater Horizon* burning, on 21 April 2010, online via the AP. Image used here as fair use for educational purposes.
